Electrical Leak Location Surveys for Landfill Caps

Authors: Rusty Hansen and Abigail Beck, P.E.

Abstract

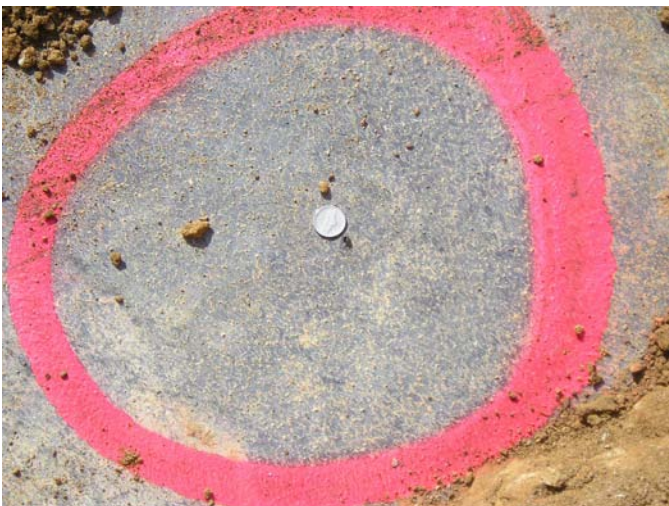
The Site 1 survey located 7 holes in the geomembrane that varied in size from 5mm to approximately 1 meter. In excavating the electrical anomalies it was found that the geocomposite and underlying geomembrane had been ripped.

Figure 6. Small puncture found under approximately 1.0 m of soil at Site 1

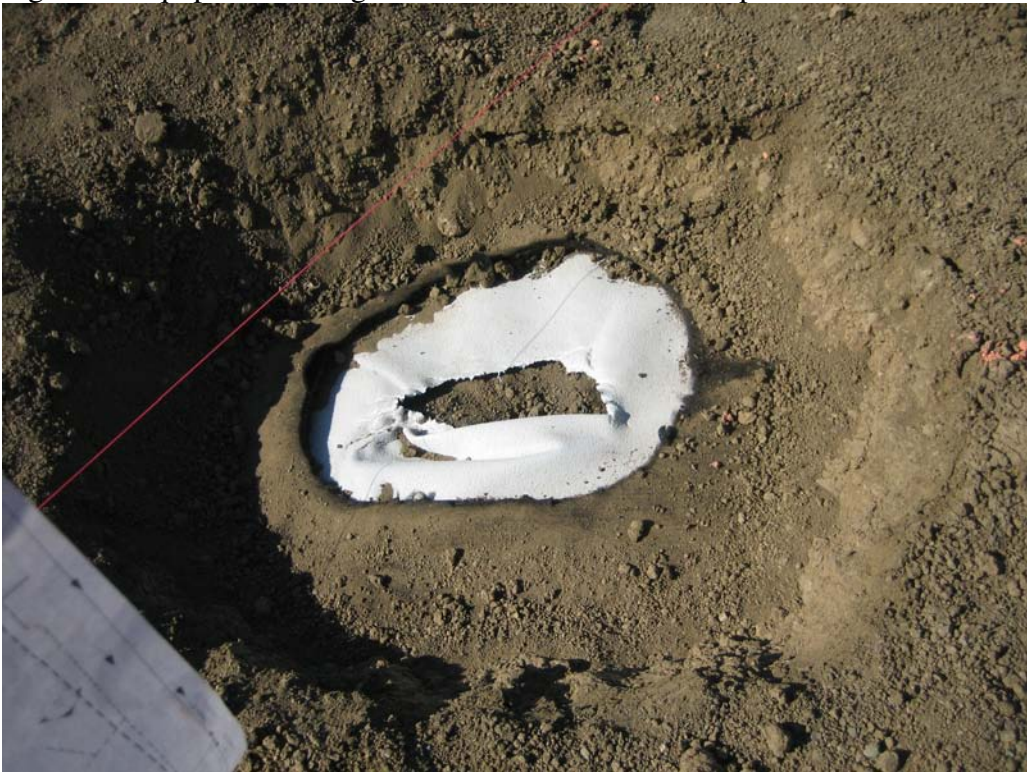
During the first hour of surveying of site 2 a 1m hole was located wear a dozer blade had torn through the geocomposite and the liner. After the hole was uncovered and isolated the current supplied to the site also dropped indicating that the site conditions are improving. As the survey continued a small cut in the liner probably caused by a utility knife being used to cut something on the liner, like the geo-composite, was located. A second tear in the liner was also located wear a dozer blade tore the liner and was covered up. In addition several areas were found were the protective cover was to thin and a dozer had torn up the liner with its tracks. The survey was also able to detect several uninstalled pipe clamps were booted pipe for a gas collection system had not been correctly sealed. The survey of site two was able to locate 8 holes in all.

Figure 7. Equipment damage located at Site 2 on side slope

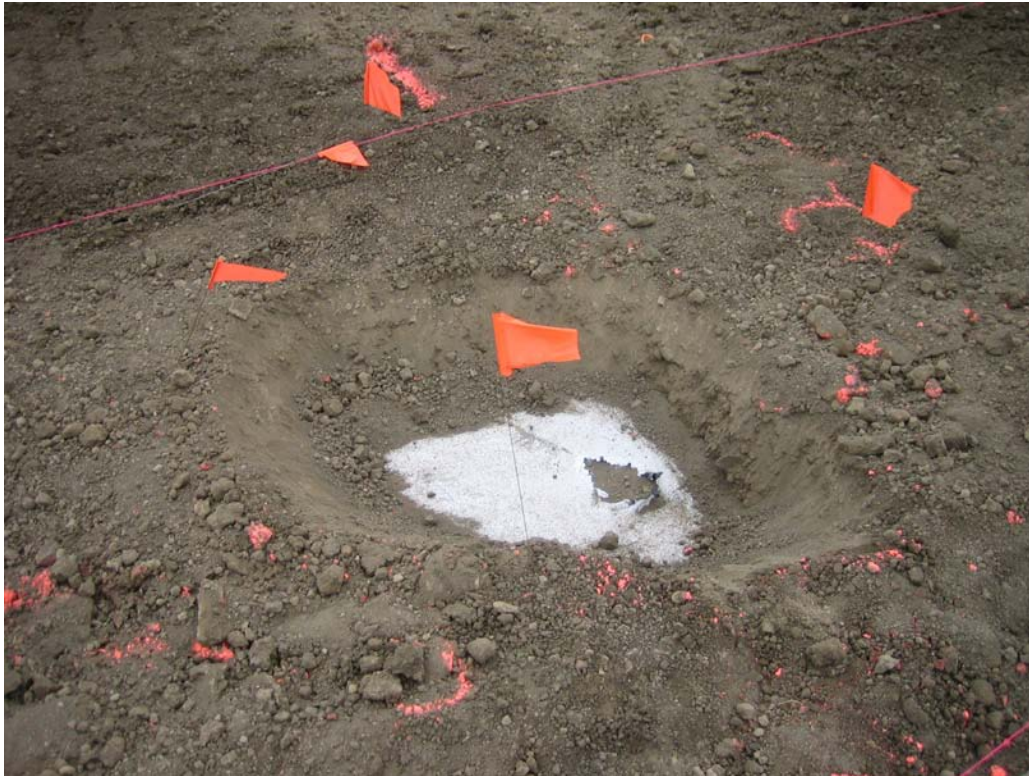
Figure 8. Equipment damage on top deck of Site 2
