Post-Construction Landfill Liner Failure and Lessons Learned

Richard Thiel, P.E., Vector Engineering, Inc, Grass Valley, CA, USA

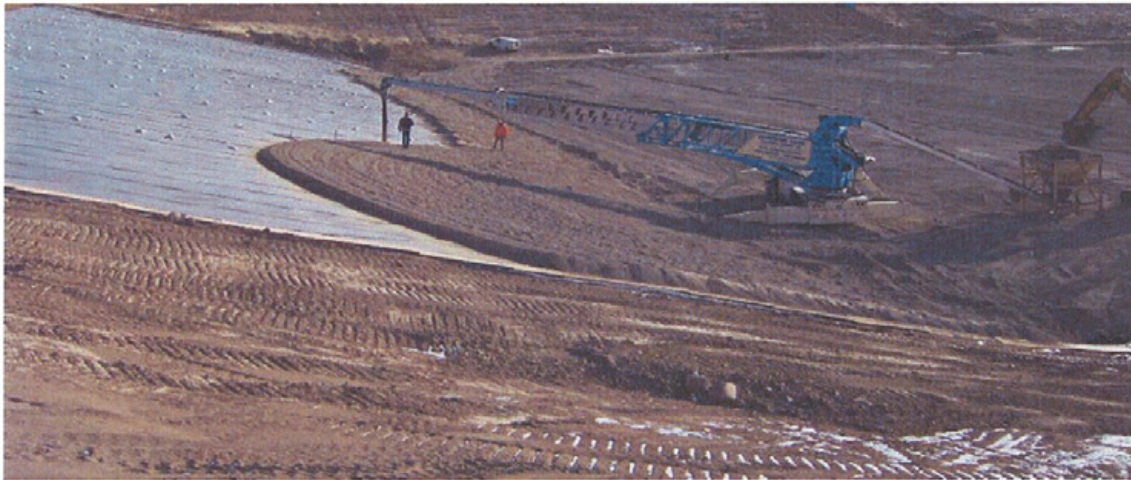
After experiencing that small failure, for which the Contractor took full responsibility, the Contractor decided to take extra caution when placing gravel on the 4:1 slope. Instead of placing and spreading gravel in the traditional manner of dumping at the toe and pushing upslope with a dozer, the Contractor elected to place all of the gravel using a "telebelt" (Figure 1). The telebelt could extend approximately 36 m, and place the desired gravel thickness relatively precisely at all slope locations using a cantilevered conveyor belt using a remote control joystick. By using the telebelt from both the bottom and the top of the slope, no piece of construction equipment was ever required to get on the slope, and the exact thickness of gravel (300 mm) was able to accurately be placed everywhere in a gentle manner. Note that this method of placement, while not extremely rare, is not common because it is substantially more expensive than the traditional method of dumping and dozer-spreading. The Contractor decided to absorb the extra cost of doing the work in this manner rather than take a chance of creating any potential slippage after his experience in the more gently sloping bottom area.

Figure 1. Placing gravel onto PVC with telebelt on 4:1 slope.

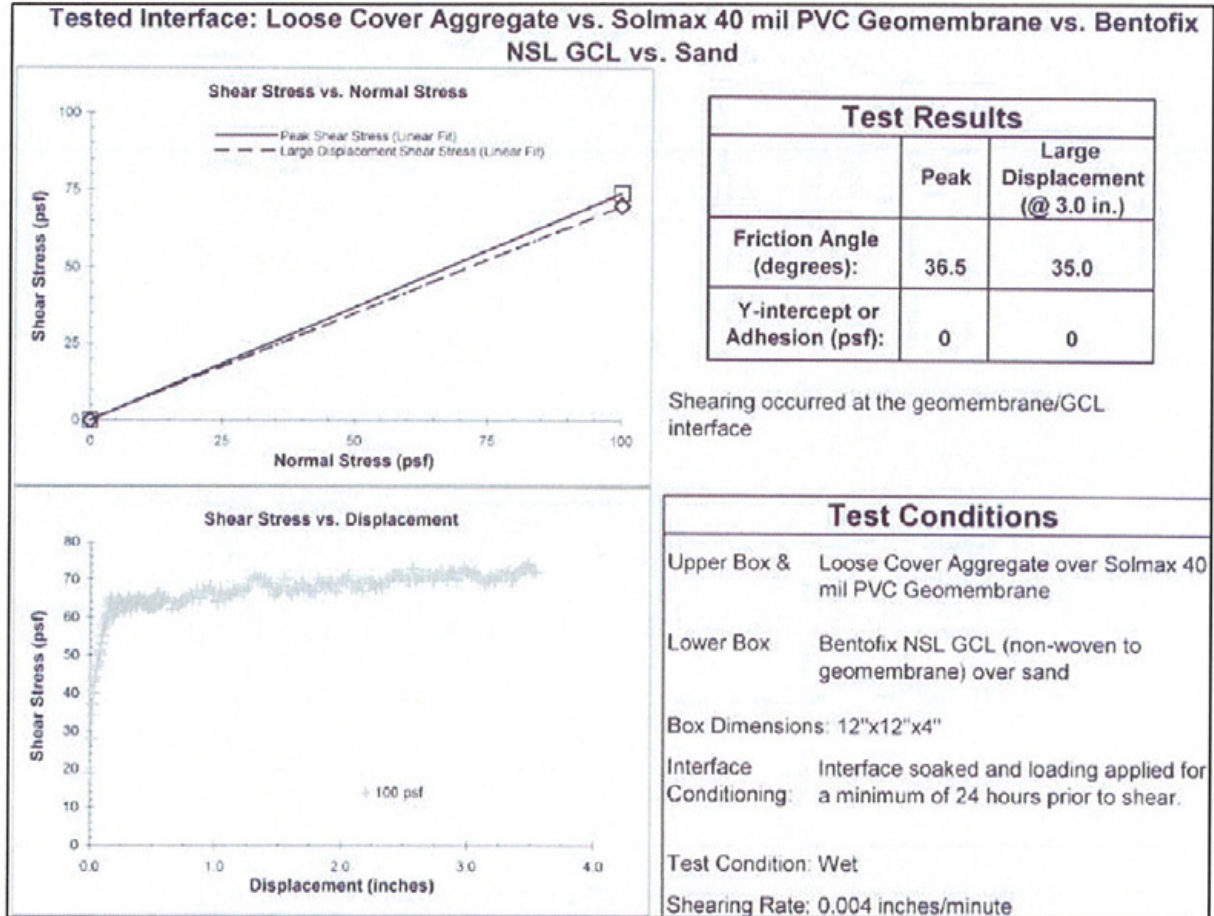
After consultation with the author, the engineer performed additional testing using samples of the exhumed GCL with fresh pieces of PVC. The GCL samples were carefully cut out, wrapped on a plastic pipe core, wrapped with plastic, and placed in sealed bags to preserve their moisture content. In the laboratory, the GCL samples were sandwiched against the PVC, and this was placed between native subgrade soils and gravel to simulated field conditions. The sandwich was hydrated under 4.8 kPa (100 pounds per square foot [psf]) below water for 24 hrs, and sheared at 0.1 mm/min. The tests were performed with a 30 cm by 30 cm square direct-shear box designed specifically for low-normal loads, and the boxes were calibrated to account for machine-friction. The resulting frictional shear strength of approximately 36 degrees peak and 35 degrees post-peak was much too high to be able to predict the failure (Figure 2).

Figure 2. Direct shear test: Interface dry for test assembly, and then submerged after assembly.

The relatively high friction angles achieved in the first round of forensic testing by the engineer were undoubtedly due to the presence of a dry interface between the PVC and the GCL. This condition existed even through the GCL from the field was pre-hydrated through months of subgrade contact, and in spite of having the test sandwich submerged under load for 24 hours. This suggests that even though a GCL may become largely hydrated, it may also produce free water from getting to the interface in a direct shear test.

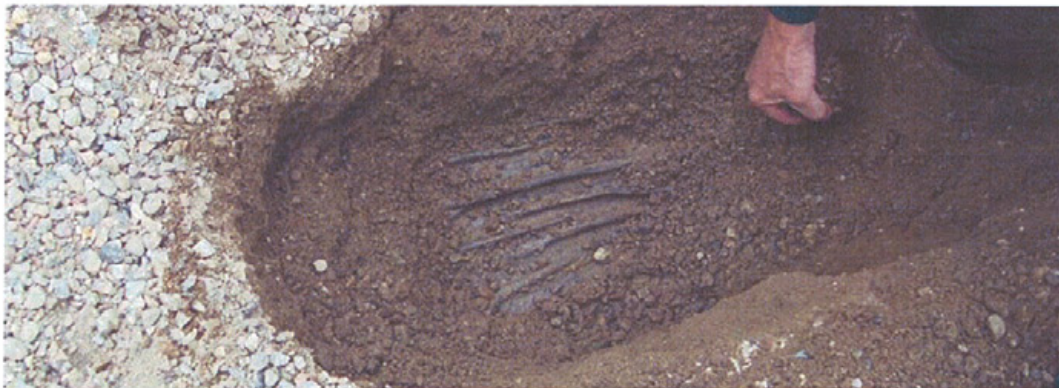
In June the author was requested by the Contractor to visit the site. The failed slope was fully visible, with exposed GCL on the upper half. The exposed GCL was dry because of the arid site conditions. It was clear that the slope had failed from crest-to-toe as evidenced by the presence of bunched-up wrinkles in the PVC at the toe (Figure 3), and bulging and open cracks in the soil cover at the toe (Figure 4). The author shoveled through some of the gravel at the edge of the failed PVC, and lifted the edge of the PVC to observe how the interface looked where it had been protected from meteoric conditions. The surface condition of the exposed un-ripped PVC appeared to be excellent in all cases. The GCL was observed to be normally hydrated (defined by the author as softened to the point that it could be deformed with thumb pressure, but was in no way very soft or oozing), as one would expect from extended contact with the subgrade.

Figure 3. Bunched-up wrinkles in PVC at toe of 4:1 slope.

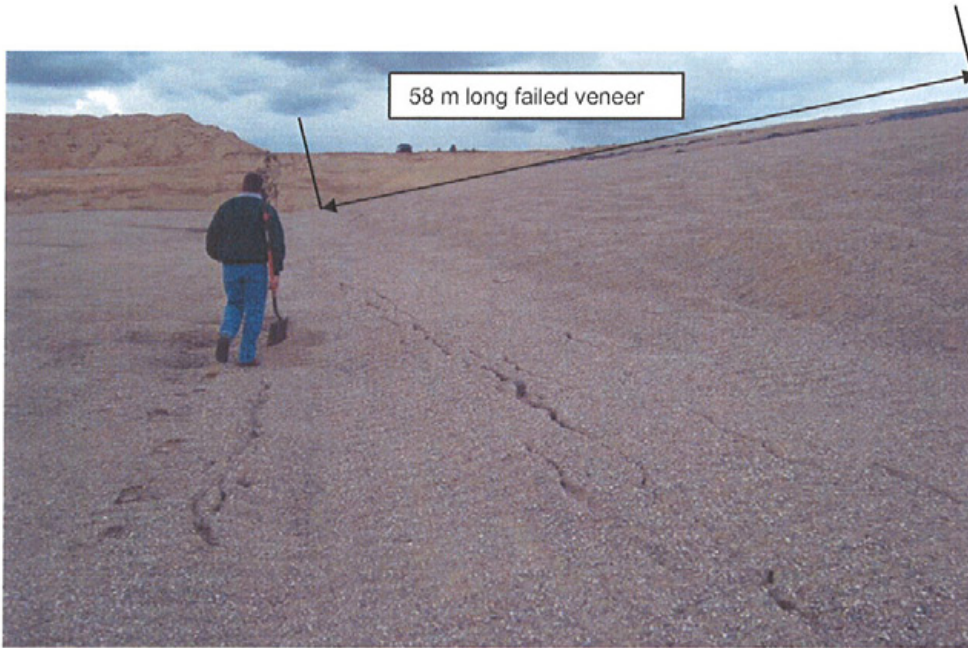
Figure 4. Deformed and cracked cover soils near toe of slope.

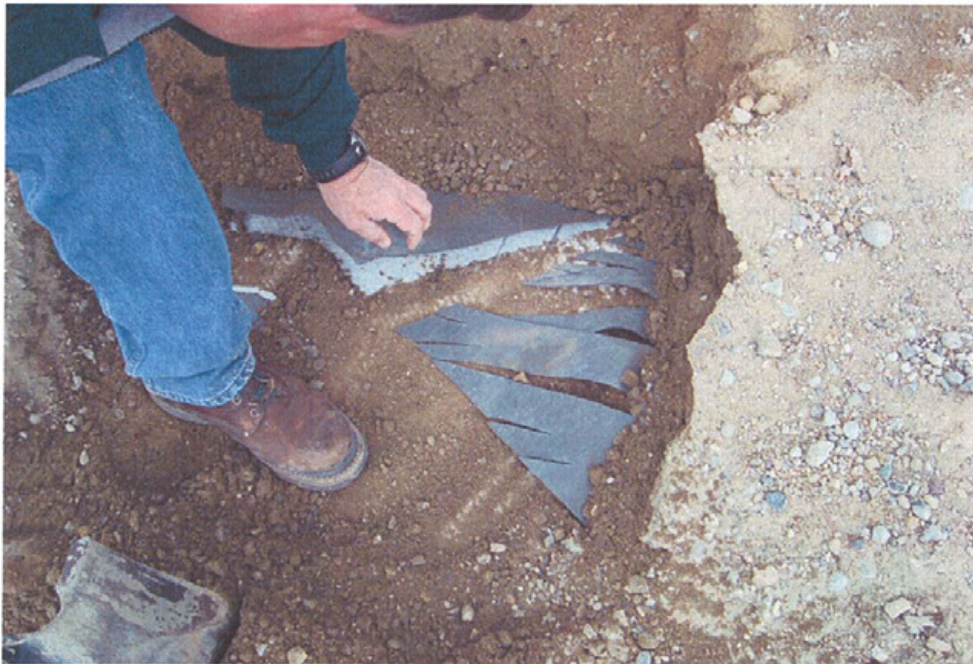
Very little bentonite was observed on the top of the GCL's upper NW geotextile. The bottom side of the PVC was observed to have a thin film of moisture (Figure 5).

Figure 5. Standing on exposed GCL (obscured with sandy gravel cover) and lifting edge of torn PVC. Clean white GCL can be seen been raised edge of torn PVC. Condensation water was noted on bottom side of PVC.

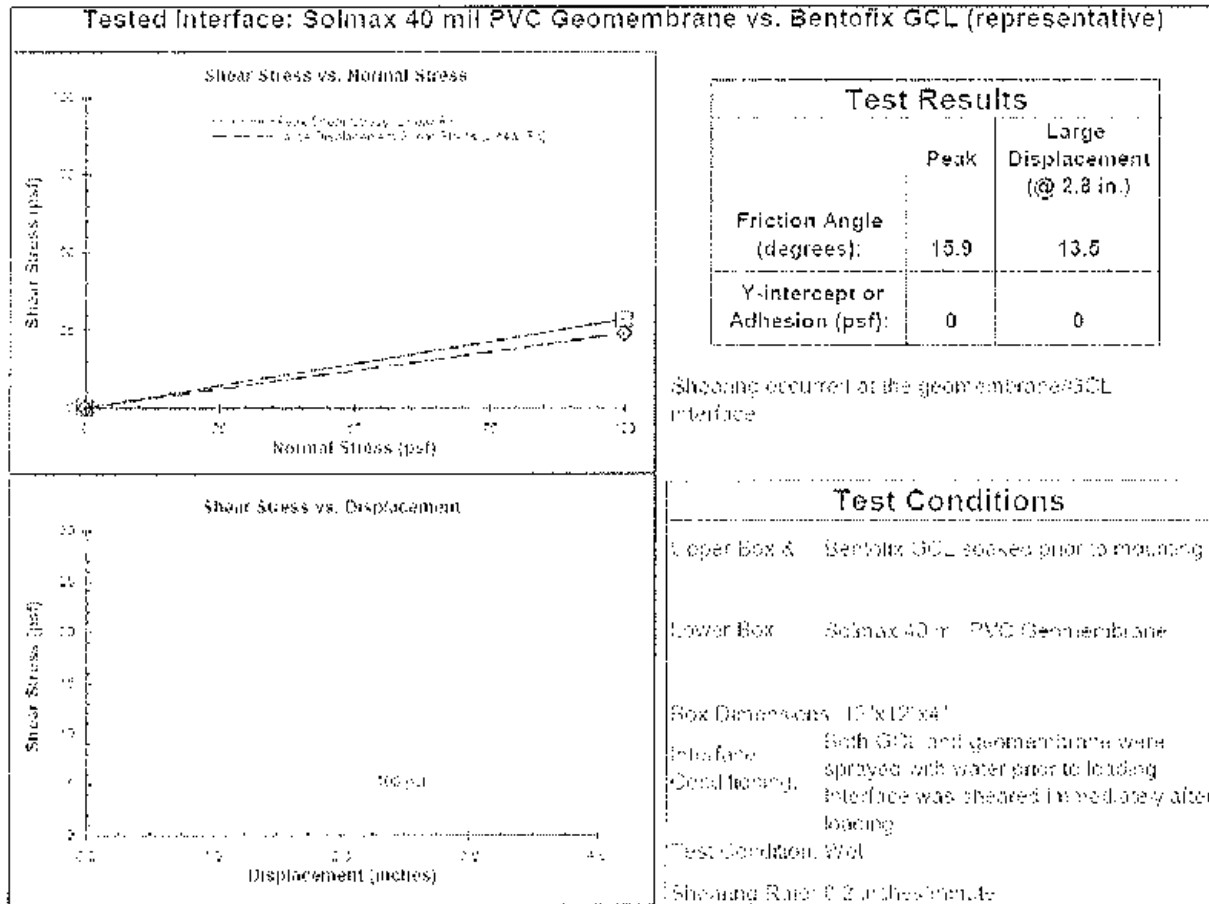
The last observation led the author to immediately commission the same laboratory used by the designer to perform a single-point shear test at 4.8 kPa (100 psf) normal load where the interface was sprayed with water immediately prior to shearing (a very common procedure when performing interface shear testing during the design phase). Using the same laboratory, equipment, and technician would remove inter-laboratory variations in test values. The test was performed with virgin materials with insignificant pre-hydration or consolidation, and sheared at 5.0 mm/min. Although other test parameters could have been used, these were the parameters chosen by the author given that he only had this single test opportunity on this project. The measured shear strength was a peak secant friction angle of 15.9 degrees and a post-peak angle of 13.5 degrees (Figure 6). These results, showing peak and post-peak frictional strength parameters straddling the slope angle, are indicative of a high probability of failure. These results also show what a large difference there is between a dry PVC/geotextile interface versus a wet one.

Figure 6. Direct shear test results: Interface sprayed with water before test assembly.

- The presence of free water is almost guaranteed in the field conditions at the geomembrane interface with underlying earthen subgrades.
- Sandwiching a GCL against a geomembrane in a dry state, loading, and then hydrating may have a very low likelihood of allowing any free water to reach the geomembrane interface.
- Laboratory direct shear testing with geomembranes against surfaces that will have access to soil moisture should always be sprayed with water before assembling them in the shear box.

1. Projects need to evaluate stability for construction conditions; not just final operational conditions. In this case, this would have meant evaluating the slope stability for the veneer system by performing interface shear strength testing at the appropriate low normal loads.
2. Direct shear tests involving clays or GCLs against geomembranes need to have the geomembrane interface sprayed with water before the test materials are assembled. Simply flooding the assembled test "sandwich" may never allow the interface to become wet. Under field conditions a deployed geomembrane will have condensation water on its bottom surface within a matter of hours, and thus spraying the interface with water is representative of field conditions. There can be a large difference in shear strengths between a dry interface and a wet one.
