Lessons Learnt and Performance – Installing and Commissioning an Ausenco Carbon Reactivation Kiln in Africa

J K Claflin¹, S R La Brooy², D Preedy³

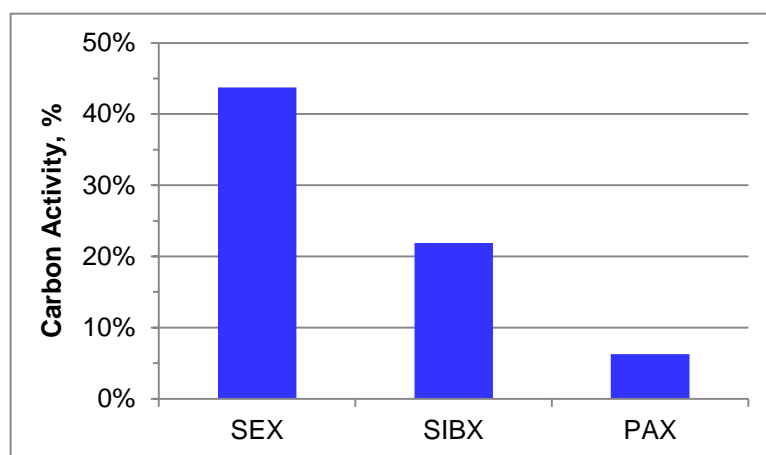
Fig. 1 - Relative carbon activity after 24 h in 20 mg/L of different xanthate solutions

Potassium Amyl Xanthate (PAX) is used at this mine site as a collector. Figure 1 (after La Brooy et al., 1986) shows the residual carbon activity after 24 h exposure to 20 mg/L of different collectors. Increasing the collector concentration further reduces the carbon activity. Frothers, can have an even more severe effect on carbon activity, with 24 h exposure to 20 mg/L frother reducing carbon activity to 10% of fresh carbon (La Brooy et al., 1986). Mahapatra (2009) observed frother induced reductions in carbon kinetic activity to around 4% of the control (Mahapatra, 2009)!

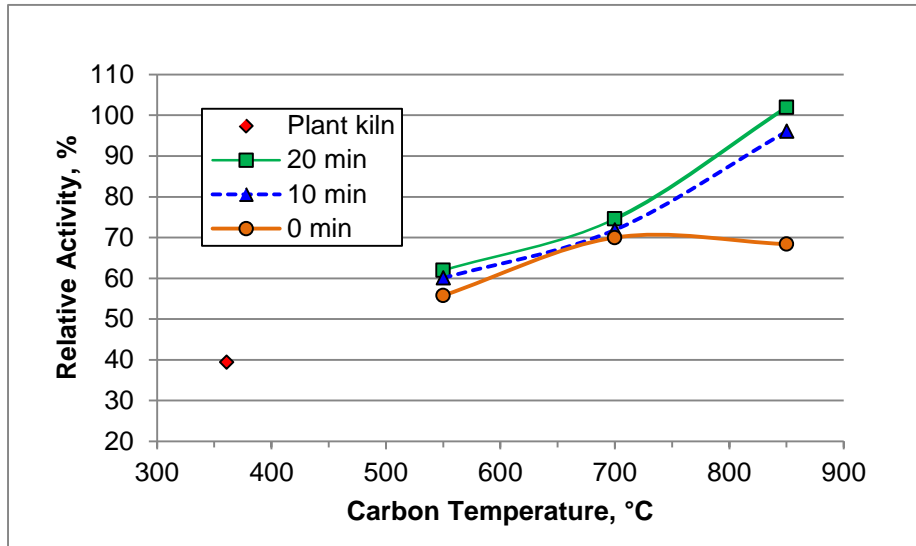
Fig 2 - Effect of time at temperature in thermal reactivation in steam atmosphere

Avraamides and La Brooy (1987) have summarised the required kiln temperature and atmosphere requirements for effective thermal reactivation. Figure 2 (after Avraamides and La Brooy, 1987) illustrates the effect of temperature and time. It can be said that for carbon temperatures up to 700°C regeneration (stripping) occurs, while above that temperature carbon reactivation occurs (La Brooy and Claflin, 2013).

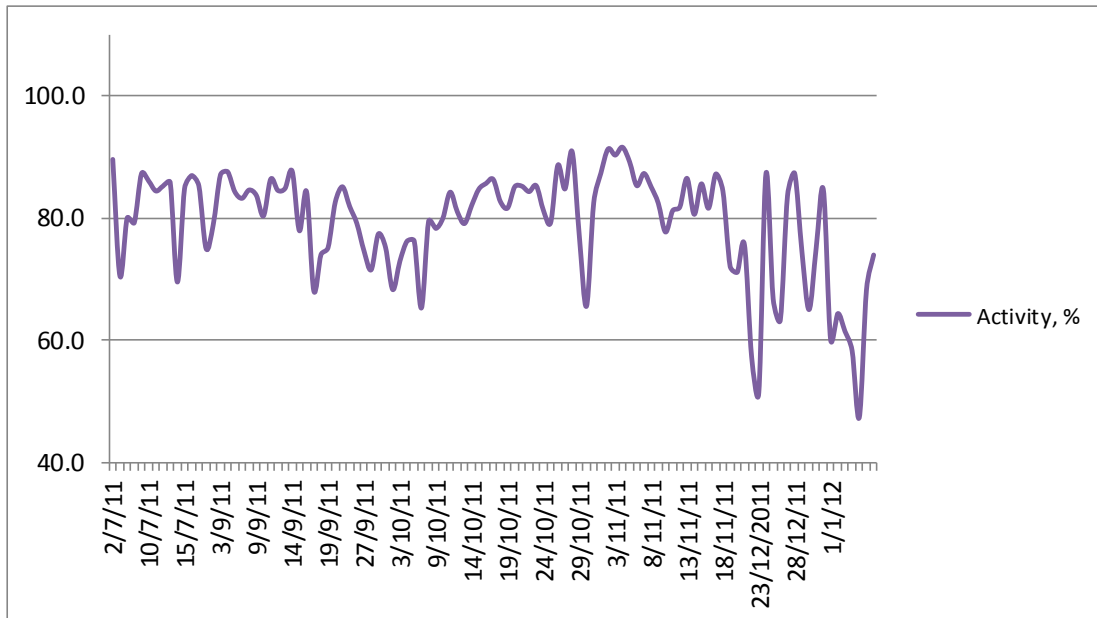
Figure 3 - Carbon Activity Pre Major Mill Upgrade (in-house test procedure)

In-house carbon activity results for 2011 are presented in Figure 3 prior to a major mill upgrade. Towards the end of that period, the mill throughput increased from 3 to 5 Mt/y. The relative carbon activity dropped from 80 to 90% to become variable between 50 and 70%. It is worth noting that in June of 2011 carbon samples were sent for external analysis. External testing reported the regenerated carbon activity to be 34 to 43% (Wardell-Johnson and Barbetti, 2011a & 2011b) at a time when in-house testing suggested activities of the order of 80%.
