Electrical Leak Location Surveys for Landfill Caps

Authors: Rusty Hansen and Abigail Beck, P.E.

Vector Engineering Inc., 143E Spring Hill Dr, Grass Valley, CA 95045, phone 530-272-2448, fax 530-272-8533, email rhansen@vectoreng.com and beck@vectoreng.com

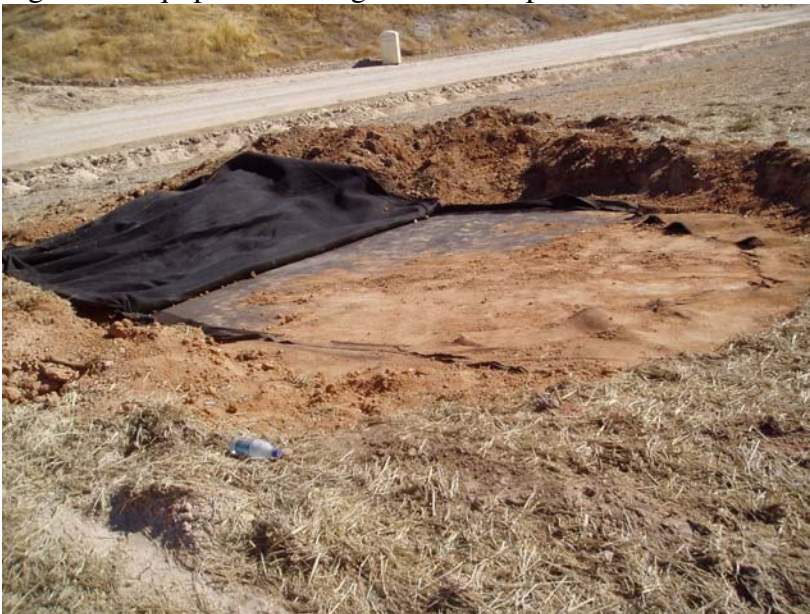
The Site 1 survey located 7 holes in the geomembrane that varied in size from 5mm to approximately 1 meter. In excavating the electrical anomalies it was found that the geocomposite and underlying geomembrane had been ripped.

Figure 5. Equipment damage on side slope of Site 1

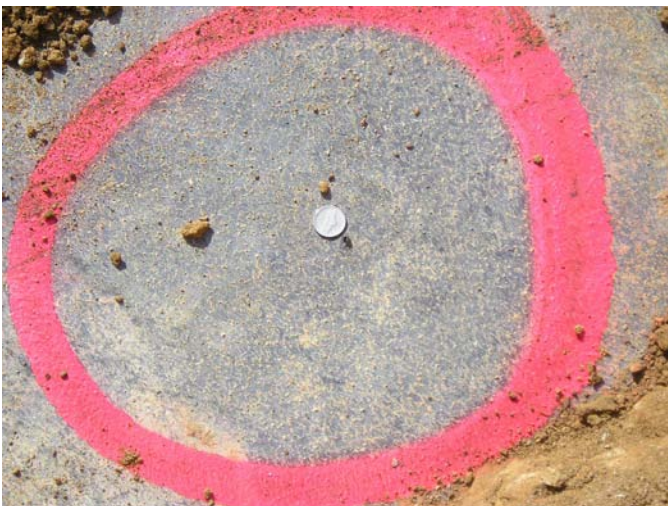
Figure 6. Small puncture found under approximately 1.0 m of soil at Site 1

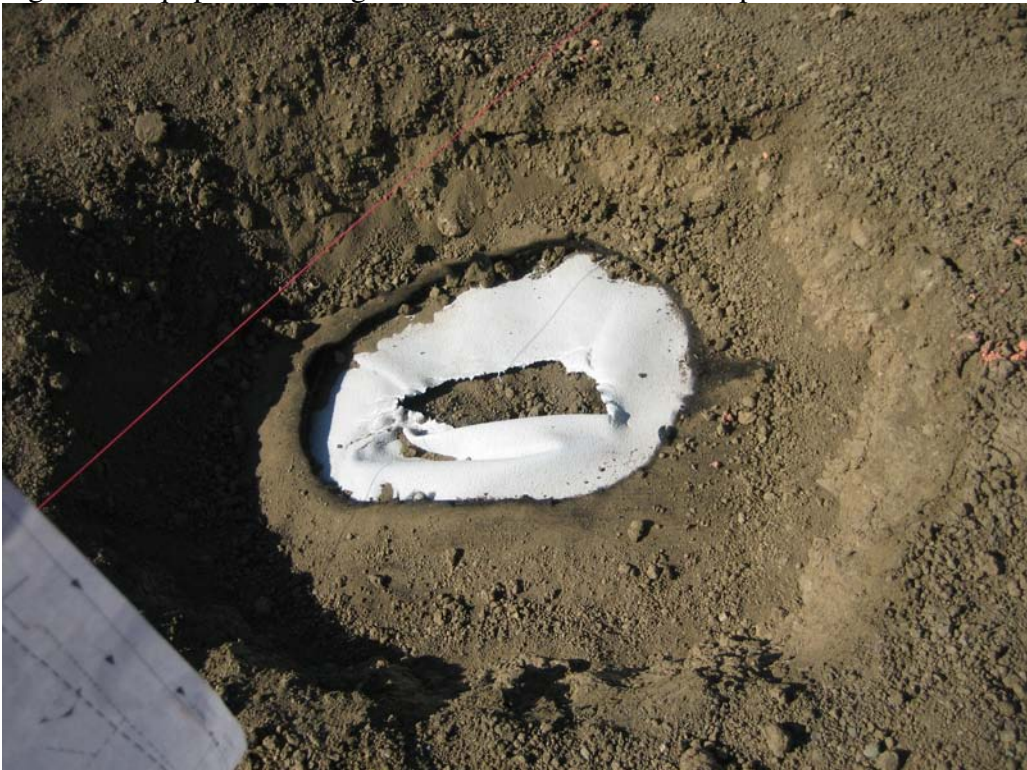
During the first hour of surveying of site 2 a 1m hole was located wear a dozer blade had torn through the geocomposite and the liner. After the hole was uncovered and isolated the current supplied to the site also dropped indicating that the site conditions are improving. As the survey continued a small cut in the liner probably caused by a utility knife being used to cut something on the liner, like the geo-composite, was located. A second tear in the liner was also located wear a dozer blade tore the liner and was covered up. In addition several areas were found were the protective cover was to thin and a dozer had torn up the liner with its tracks. The survey was also able to detect several uninstalled pipe clamps were booted pipe for a gas collection system had not been correctly sealed. The survey of site two was able to locate 8 holes in all.

Figure 7. Equipment damage located at Site 2 on side slope
