# CASE HISTORY OF EXPOSED GEOMEMBRANE COVER FOR BIOREACTOR LANDFILL

*R. THIEL\*, S. PURDY\*, AND R. YAZDANI\*\**

**SUMMARY:** Design challenges for installing an exposed geomembrane cover for a landfill included (a) providing adequate anchorage of the geomembrane to resist the typically strong wind forces, (b) making sure all important geomembrane welds were constructed so that they would only be stressed in a shear mode and not in peel, (c) managing intense stormwater runoff from the exposed geomembrane area, (d) ballast for low-wind conditions, and (e) managing the large number of penetrations through the cover geomembrane that would cause localized stresses during wind storms. Design and operational lessons learned are presented in the paper.

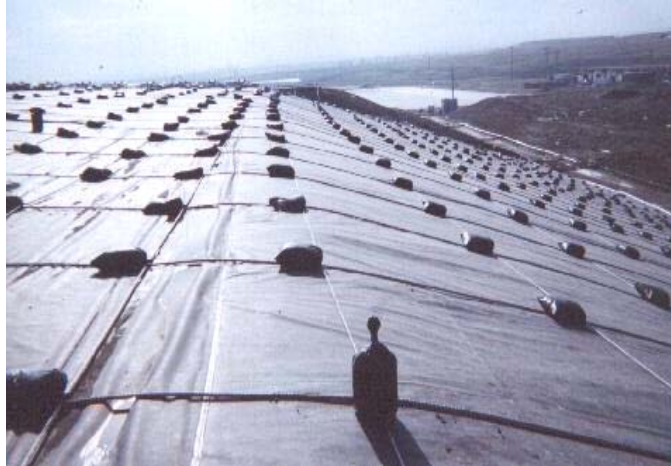
**Figure 1. Completed Exposed Geomembrane Cover System from Top Crest of Slope.**

consideration for this application. Several other design references are available in the literature describing the approach (Gleason et al., 1998, Gleason et al., 1999, Germain et al., 2001). Using this design method, the only viable hold-down mechanism to keep the cover from being blown away due to a significant wind velocity is to use fully backfilled anchor trenches or soil berms on benches. The primary author believes this is conservative as evidenced by successful designs that have not used such extensive ballasting. Nonetheless, to reduce the probability of failure, the more conservative design approach was used for a maximum assumed wind velocity of 40 m/s. A general picture of the completed cover system is shown in Figure 1.

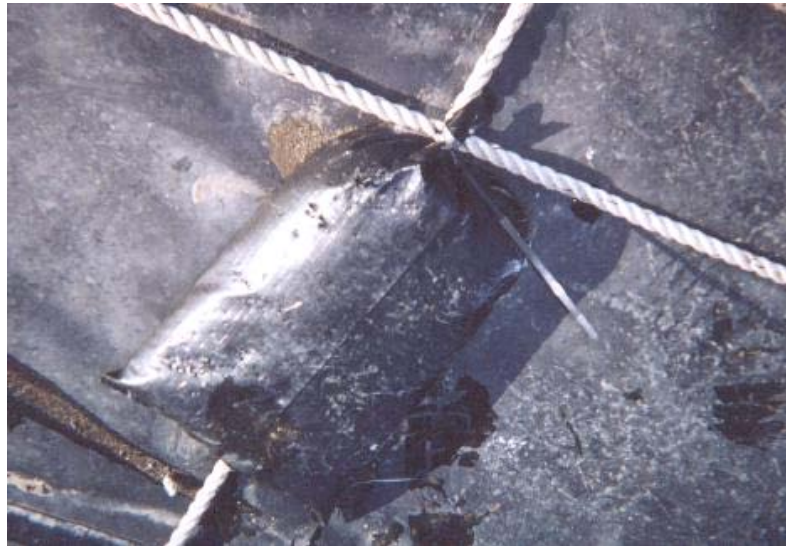
Figure 3. Photo of Sandbag Attached to Rope Node (note bird pecking holes).

***The interesting aspect of the ballast installation lies in the exact details of how it is installed and maintained in place. If sand bags were simply to be placed on the liner with no other restraint, the first real wind would cause the sandbags to be tossed around and end up at the toe of the slope. To keep the bags in place, the bags are tethered together with a rope grid made from 3-strand twisted polypropylene rope. The horizontal ropes were specified as 10 mm rope, and the vertical ropes were specified as 20 mm rope because of the greater load they might carry. At each node where the ropes crossed, a sand bag was tied. The type of attachment affects the long-term durability. Plastic electrical ties eventually break due to exposure and stress. Crimped wire hog rings are the most long lasting. Experience has shown that if installers of this ballast system attempt to be frugal or save time by leaving out ropes, or not adequately fastening the bags and fixing the nodes tightly, they will end up redoing the work.***

*each way. Experience has shown this material lasts approximately 5 years in an exposed environment. A typical sandbag attachment at a rope intersection is shown in Figure 3.*

***The issue of the birds was foreseen, but not to the degree it was actually experienced. The two main areas that the birds peck at are the flaps on geomembrane seams, and the sand bags. If the flap left over from welding the geomembrane was left in place, the birds felt an irresistible need to peck inside the flap, thereby endangering the geomembrane. This was solved by cutting away the flap, and the birds stopped pecking on the seams. Solving the issue for the sandbags has been more problematic. The problem became so severe, that tires with covers were placed over the sandbags to protect them. The bottom side of the tires had to be cut out to fit over the sandbags, and a stiff piece of polyethylene geomembrane inserted over the top of the tire to keep the birds out. A photo of the tire protection installation is shown in Figure 5.***

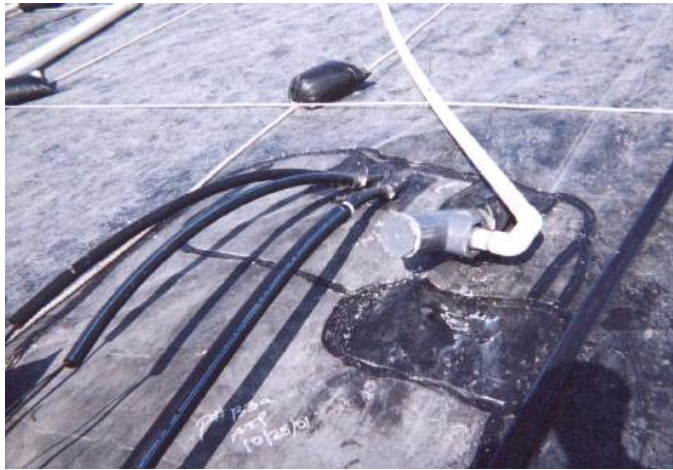
Figure 4. Photo of Pipe Penetration Group.

*The type of boot specified for the penetration was a pre-manufactured boot and skirt that could be welded to the geomembrane cover, and clamped to the pipe. In the two years that the exposed cover system has been operational, only one tear occurred. A photograph of some typical pipe boots is presented in Figure 4.*

*To the extent possible it is desirable that pipe penetrations be reduced or eliminated because experience has shown that these locations will provide the most operational problems over time with exposed geomembrane covers. The nature of the Yolo County test cells, however, is such that numerous penetrations are required for purposes of instrumentation and operation of the test cells. The design noted that problems and repairs at the penetration points would be expected over time due to wind uplift. The nature of the problems might include ripped cover material, ripped boots, and broken pipes. As problem areas become identified and repaired, it is possible that additional cover ballast could be added at those locations to reduce the chances of repeat failures at the same locations. Over the 1.3 ha site, a total of 107 pipe penetrations were installed!*
