Electrical Leak Location Surveys for Landfill Caps

Authors: Rusty Hansen and Abigail Beck, P.E.

Abstract

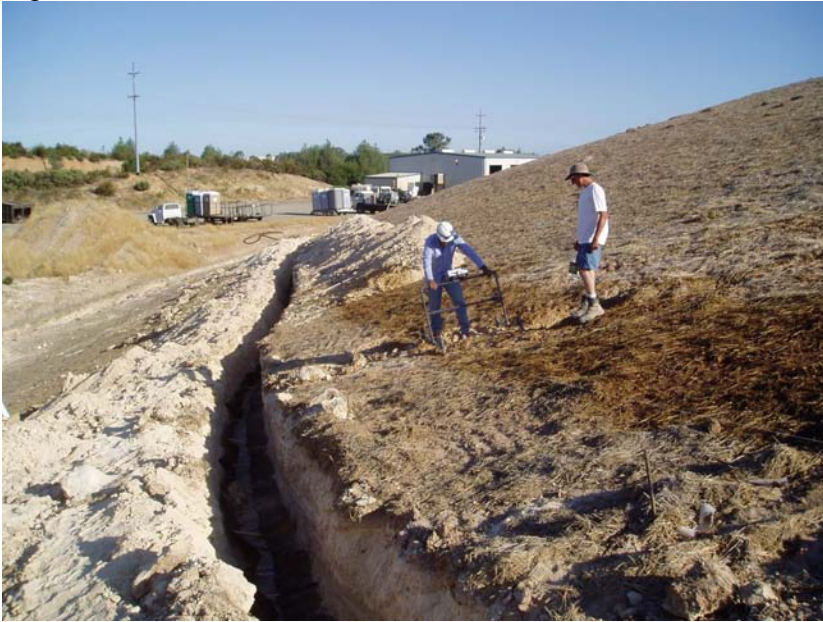
Figure 1. Perimeter Trench

For Site 1, the ELL survey was specified after the landfill was in its final closure configuration. Therefore, a trench was dug around the entire perimeter of the landfill, as shown in Figure 1. A geocomposite drainage net was installed as part of the closure cap and recent rains had saturated this material. Therefore, geocomposite was also separated and allowed to dry out in order to prevent electrical conductivity through the trench, as shown in Figure 2.

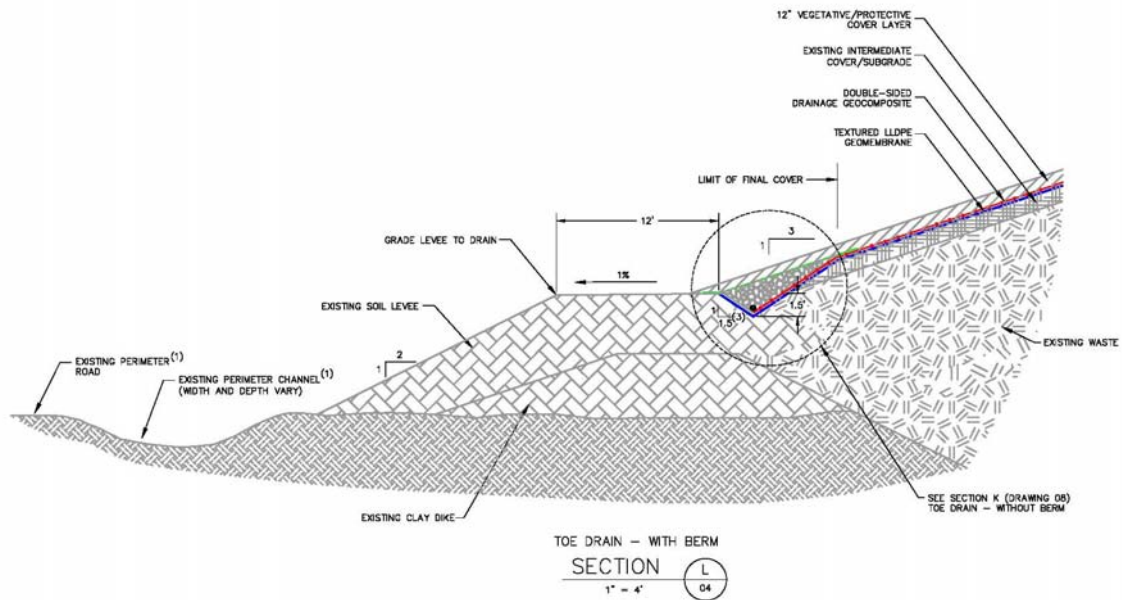
Figure 3. Design Detail of perimeter isolation

For Site 2, the ELL survey was specified as part of closure construction so that a novel perimeter isolation detail was created early in the design process. This detail allowed the liner to be extended from the anchor trench to create an isolation strip around the perimeter of the cap.

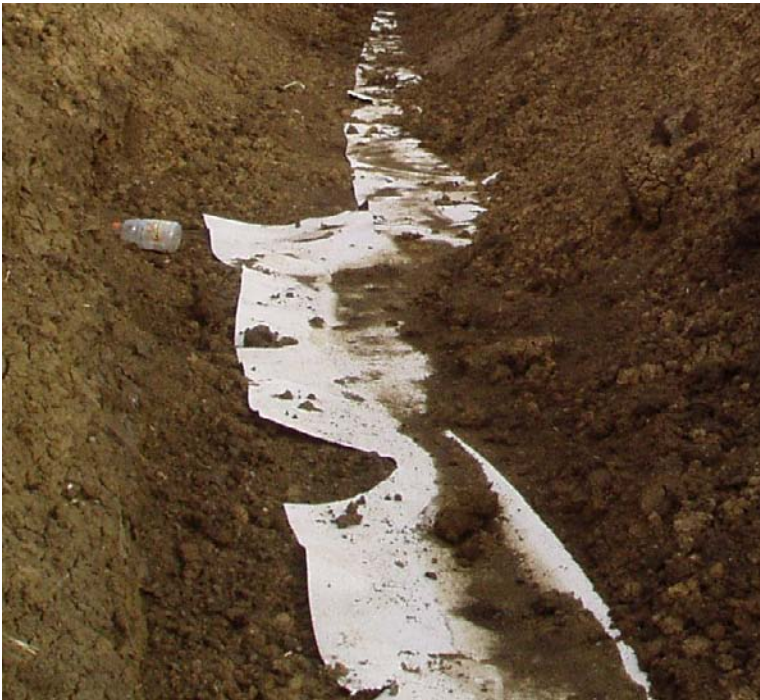
A photo of the isolation strip at the time of the ELL survey is provided as Figure 4.

The Isolation of the site is critical since any soil, water, or other conductive material bridging the survey area and the grounded area can potentially ground out the survey and mask the presence of leaks through the geomembrane. The exposed liner trenches shown in the previous photos were covered after the survey was completed.
