## **The Ongoing Quality Issues Regarding Polyethylene Geomembrane Material Manufacturing & Installation**

R.B. Erickson, Vector Engineering, Inc., Grass Valley, California, USA  
R.S. Thiel, Vector Engineering, Inc., Grass Valley, California, USA  
J. Peters, Vector Chile Limitada, Santiago, Chile

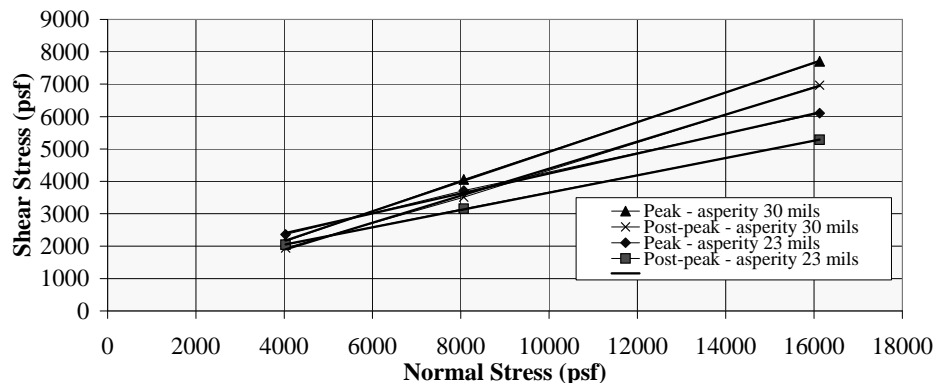
For example, as shown in Figure 1, when the asperities of the co-extruded surface increased from an average 0.58 mm (23 mil) to 0.75 mm (30 mil), the peak and large displacement interface shear strength against a nonwoven geotextile increased approximately 27% and 30%, respectively. Thus, the pattern and magnitude of the asperities play a key roll in the derived geomembrane shear strength values. Designers can use this to their advantage when specifying geomembrane asperity requirements.

Figure 1. Geomembrane interface shear strength against a nonwoven geotextile (Thiel, 2001).

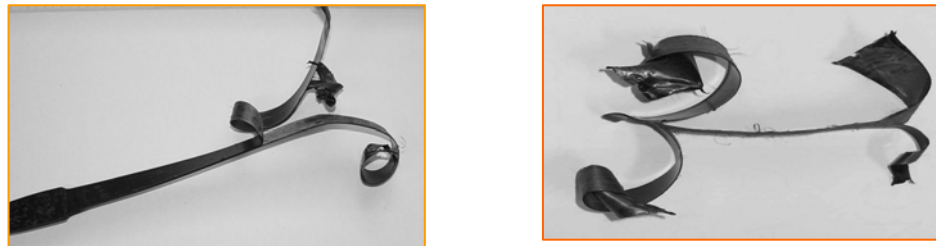
Separation in plane (SIP) of textured HDPE geomembranes is typically observed as a result of destructive seam peel testing on the 25 mm uniform strip specimens. The separation is an internal failure/peeling of the geomembrane and may travel within the sheet for a considerable distance (Figure 2). The issue of separation in plane failure within HDPE geomembranes was first discussed in 2001 (Smith, 2001) and has since been given increasing attention. Table 1 summarizes the documented observations and conclusions regarding SIP to date.

Figure 3. SIP in 25 mm wide HDPE co-extruded texture geomembrane specimens in single and multiple failure planes.

As summarized in Table 1 (GSI, 2005), it is difficult to definitively say what the specific problem(s) underlying SIP can be attributed as there currently is no industry consensus. SIP is a problem which arises every couple years, generally resulting from the PE geomembrane manufacturing process, cooling conditions, certain resins or mater batches (carbon black/carrier resin additive), or any combination there of. This is not an industry wide issue but a product specific manufacturing issue that has occurred, albeit seldom, in North and South American manufactured HDPE co-extruded texture geomembranes. It has been observed primarily in co-extruded textured HDPE geomembranes with thickness 1.0 mm and greater.
